In Situ Corrosion and Heat Loss Assessment of Two Nonstandard Underground Heat Distribution System Piping Designs

Final Report on Project F07-AR01

June 2011

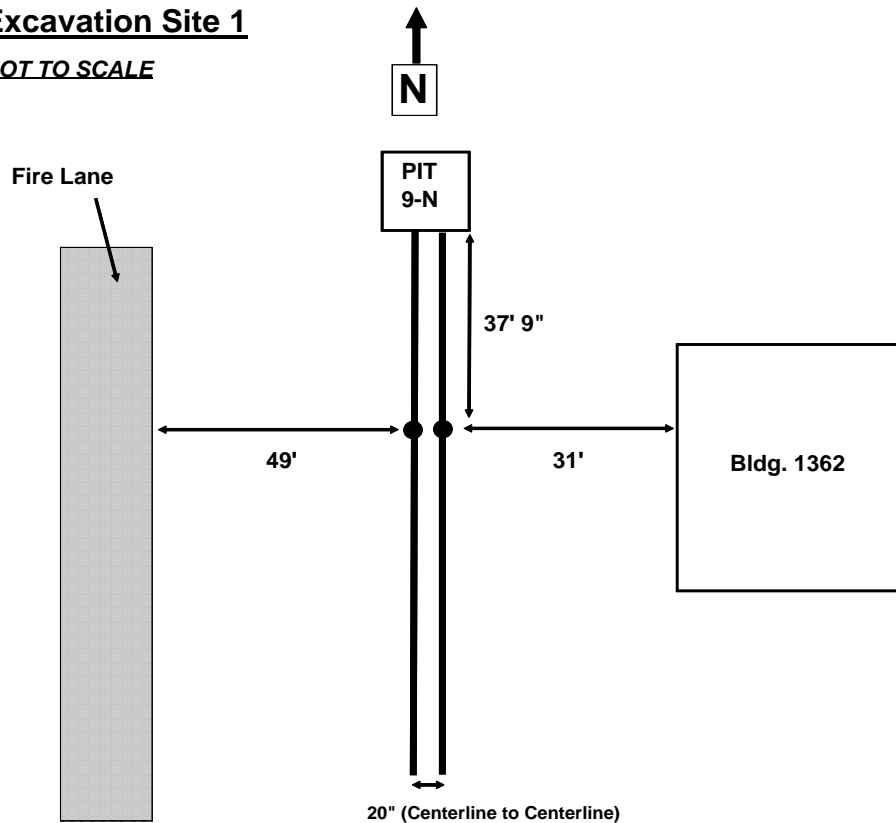
Figure 11. North Loop excavation site 1.

1. Site Location: North Loop. Approximately 35 feet south of MH- 9N, 30 feet west of Bldg. 1362. Vanguard ICT as-built Ref. Sheet No. M-8
2. Conduit Size: Supply (East) – 57.75" Circ. (18.4" Dia.); 8" HTWS per Ref. Sheet No. M-8; Return (West) – 56.00" Circ. (17.8" Dia.); 8" HTWS per Ref. Sheet No. M-8

8. Inclusions, if any: Small-medium rocks, occasional construction debris
9. Depth of Burial: 62" below grade to conduit top.
10. Conduit Separation: 20" centerline to centerline

11. Native soil type at burial depth (@ASHRAE Site 1):
 - a. Claystone
 - b. Grain: Fine
 - c. Consistency: Hard
 - d. Moisture: Moderate-High
 - e. Clay: High
 - f. Plasticity: Moderate-High
 - g. Color: Brown
12. Soil Resistivity at burial depth: 2,000. ohms/cm²
13. Photo Documentation: See Figure 12 and Figure 13 below.
14. Any other data that would influence the system: None

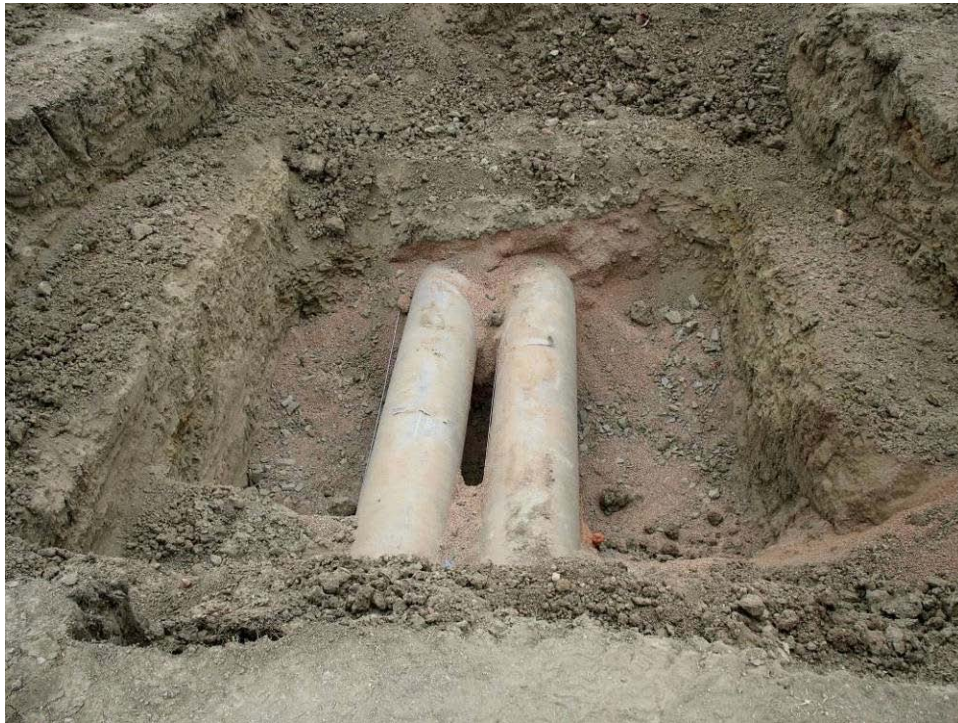
Figure 12. Site 1 excavation, facing south.

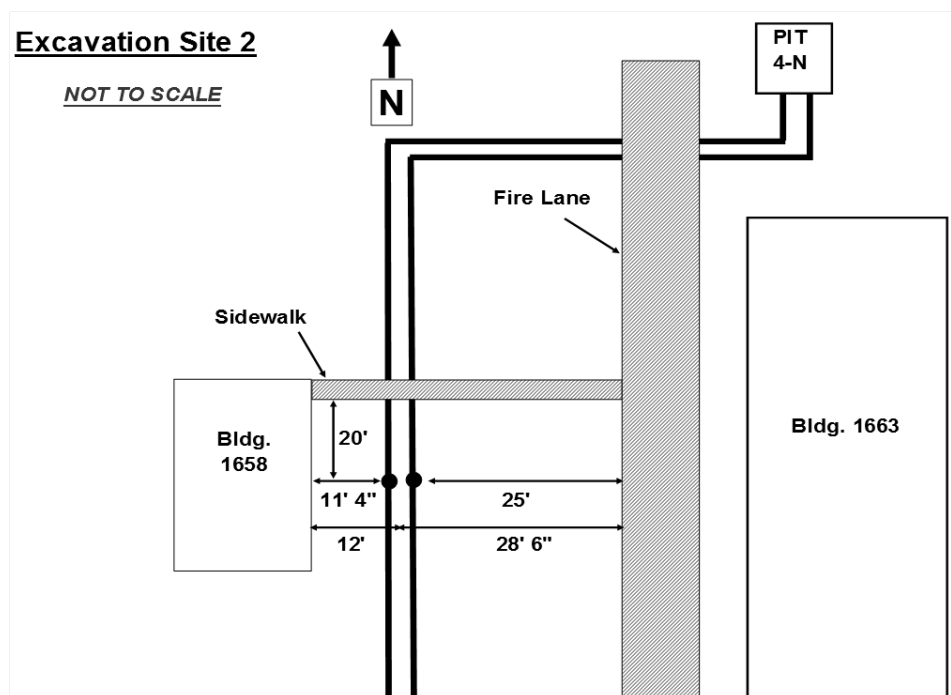
Figure 14. Site 2 schematic.

1. Site Location: North Loop. Approx. 12 feet east of Bldg 1658. Vanguard ICT as-built Ref. Sheet No. M-4
2. Conduit Size: Supply (East) – 18” Dia.; 10” HTWS per Ref. Sheet No. M-4; Return (West) – 18” Dia.; 10” HTWS per Ref. Sheet No. M-4.
Note: Casing diameter measured at dig site approx. 18”. Casing circ. for both conduits was measured at adjacent manholes and determined to be 64” (20.4” dia.). Conduit dimensions at excavation site agree with Perma-Pipe “Multi-Therm 500” nominal specs for 10” carrier with 2” mineral wool insulation.

13. Any other data that would influence the system: Conduits are relatively close to Bldg. 1658 to west. Building is Butler-type on concrete slab at grade.

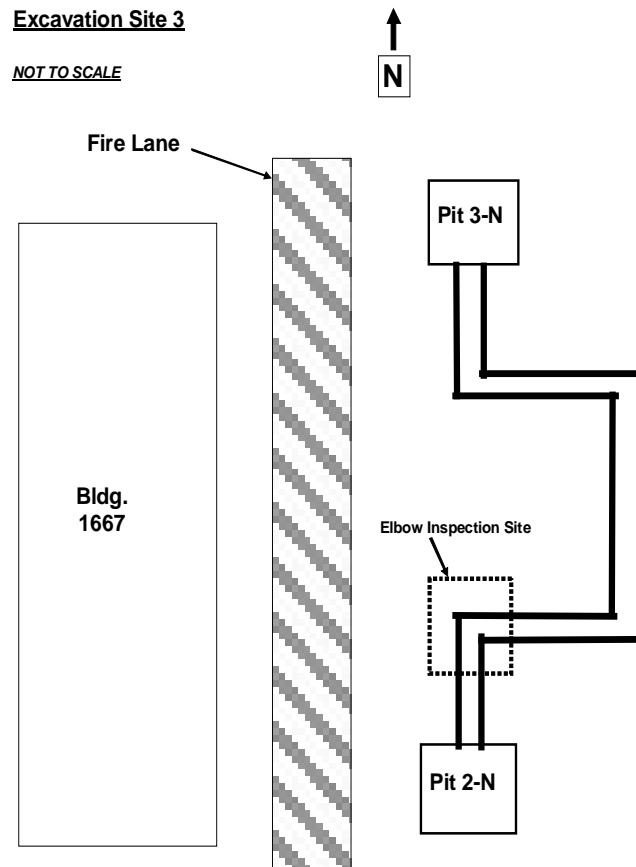
Figure 17. Site 3 schematic diagram.

1. Site Location: North Loop. Approximately 50 feet north of MH-2N, east of Bldg. 1667. Vanguard ICT as-built Ref. Sheet No. M-4
2. Conduit Size: Supply (East) – 70.75" Circ. (22.5" Dia.); 12" HTWS per Ref. Sheet No. M-4; Return (West) – 71" Circ. (22.6" Dia.); 12" HTWS per Ref. Sheet No. M-4
3. Conduit Temperature: Supply and Return – Slightly warm to touch when first exposed, temperature dropped quickly to ambient after exposure.
4. Outer Jacket Condition: Supply – Good; Return – Good.
5. Damage Observation (Abrasion, wear, damage, workmanship): In general, outer casing shows no significant damage, wear or abrasion; construction workmanship is good. Field splice boot and casing at elbow apparently damaged during excavation. Boot was cut and casing punctured/eroded. Repair completed by filling cavity behind puncture with

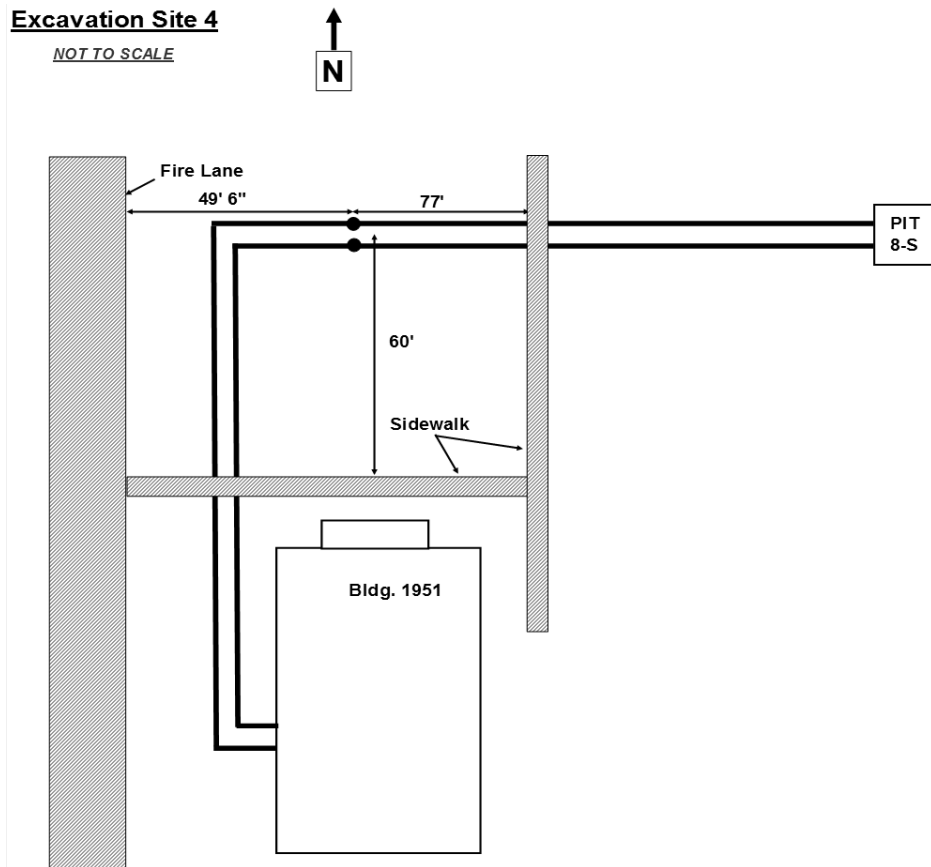
Figure 22. Site 4 schematic.

1. Site Location: South Loop. Approximately 60 feet north of Bldg. 1951, west of MH-8S. Vanguard ICT as-built Ref. Sheet No. M-3
2. Conduit Size: Supply (South) - 26.5" Circ. (8.4" Dia.); 2" HTWS per Ref. Sheet No. M-3; Return (North) - 27" Circ. (8.6" Dia.); 2" HTWS per Ref. Sheet No. M-3. Note: Outer casing measurements agree with Thermacor "Duo-Therm 505" specifications for 2" HTW carrier.

- a. Fat Clay
 - b. Grain: Fine-Coarse
 - c. Consistency: Very Stiff
 - d. Moisture: Moderate
 - e. Clay: High
 - f. Plasticity: Moderate-High
 - g. Color: Brow/Light Brown
11. Soil Resistivity at burial depth: 10,700. ohms/cm²
12. Photo Documentation: See Figure 23 and Figure 24.
13. Any other data that would influence the system: None

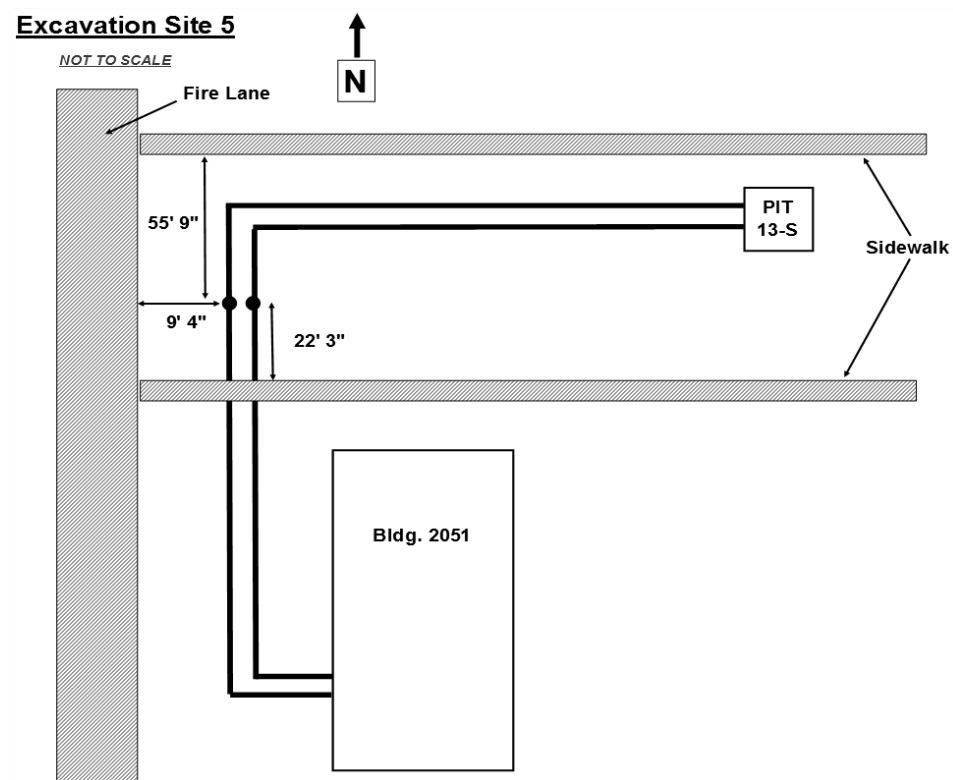
Figure 25. Excavation site 5 schematic.

1. Site Location: South Loop. North of Bldg. 2051, west of MH-13S. Vanguard ICT as-built Ref. Sheets No. M-5 and M-6
2. Conduit Size: Supply (East) – 27” Circ. (8.6” Dia.); 2” HTWS per Ref. Sheets No. M-5 and M-6; Return (West) – 27” Circ. (8.6” Dia.); 2” HTWS per Ref. Sheets No. M-5 and M-6. Note: Outer casing measurements agree with Thermacor “Duo-Therm 505” specifications for 2” HTW carrier.

- e. Clay: Moderate-High
 - f. Plasticity: Moderate
 - g. Color: Brown/Light Brown
11. Soil Resistivity at burial depth: 20,000. ohms/cm²
12. Photo Documentation: See Figure 26 and Figure 27.

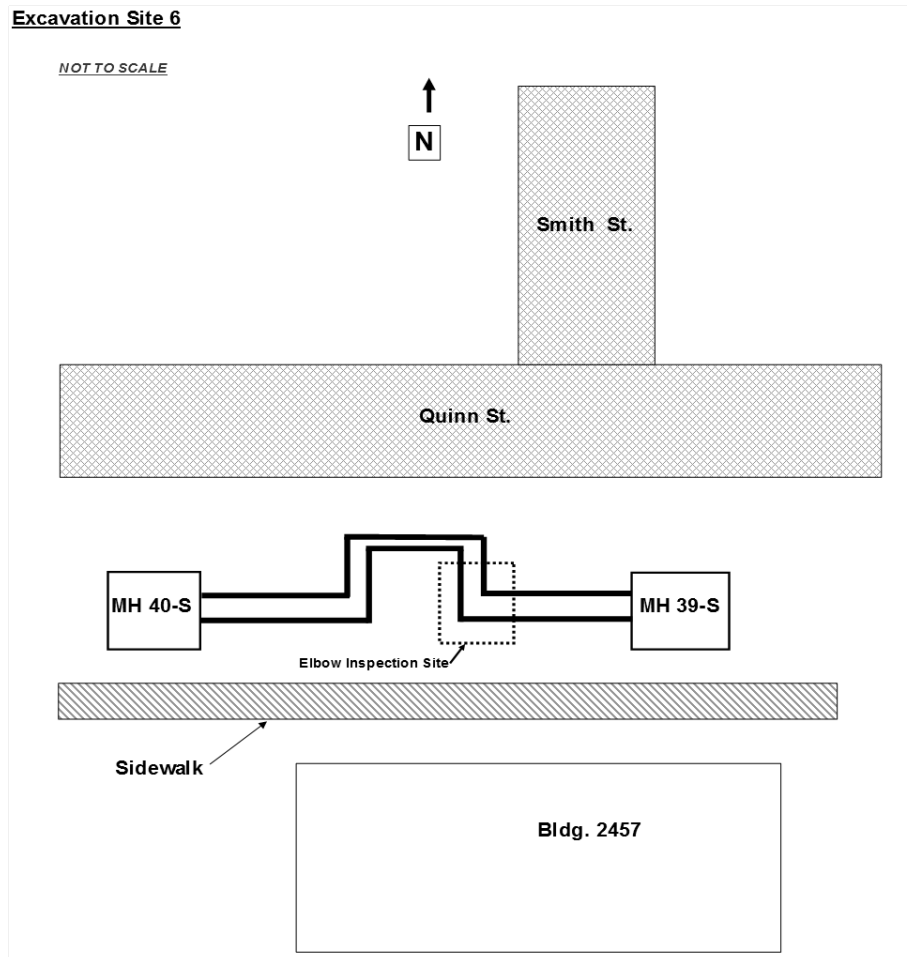
Figure 28. Excavation site 6 schematic.

1. Site Location: South Loop. North of Bldg. 2457, approx. mid –way between MH-39 and MH-40. Vanguard ICT as-built Ref. Sheet No. M-16.
2. Conduit Size: Supply (East) – 34.25" Circ. (10.9" Dia.); 3" HTWS per Ref. Sheet No. M-16; Return (West) – 34.25" Circ. (10.9" Dia.); 3" HTWS per Ref. Sheet No. M-16. Note: Outer casing measurements agree with Thermacor "Duo-Therm 505" specifications for 3" HTW carrier.
3. Conduit Temperature: Supply and Return – Slightly warm to touch when first exposed, temperature dropped quickly to ambient after exposure.
4. Outer Jacket Condition: Supply - Good; Return – Good.

5. Damage Observation (Abrasion, wear, damage, workmanship): No significant damage, wear or abrasion; construction workmanship is good.
6. Nature of "Select Backfill": Pea gravel and native earth used for backfill after system installation.
7. Inclusions, if any: Small-medium rocks, occasional construction debris
8. Depth of Burial: 42" below grade to conduit top.
9. Conduit Separation: 15" (east-west run), 20" (north-south run) center-line to centerline
10. Native soil type at burial depth (@ ASHRAE Site 6):
 - a. Sandy Lean Clay
 - b. Grain: Fine-Coarse
 - c. Consistency: Very Stiff
 - d. Moisture: Low-Moderate
 - e. Clay: Moderate-High
 - f. Plasticity: Moderate
 - g. Color: Brown
11. Soil Resistivity at burial depth: 2,000. ohms/cm²
12. Photo Documentation: See Figure 29 and Figure 30.
13. Any other data that would influence the system: N/A. Elbow inspection site.

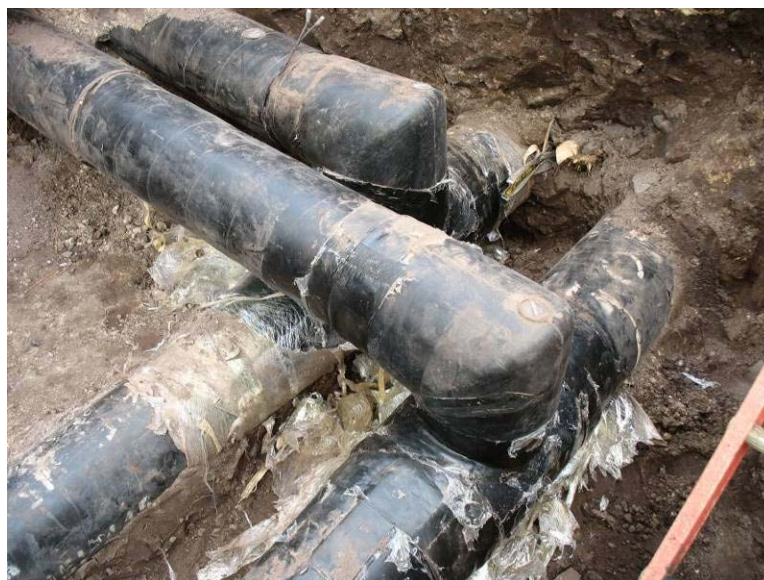
Figure 47. Branch to Bldg. 649 (upper left).

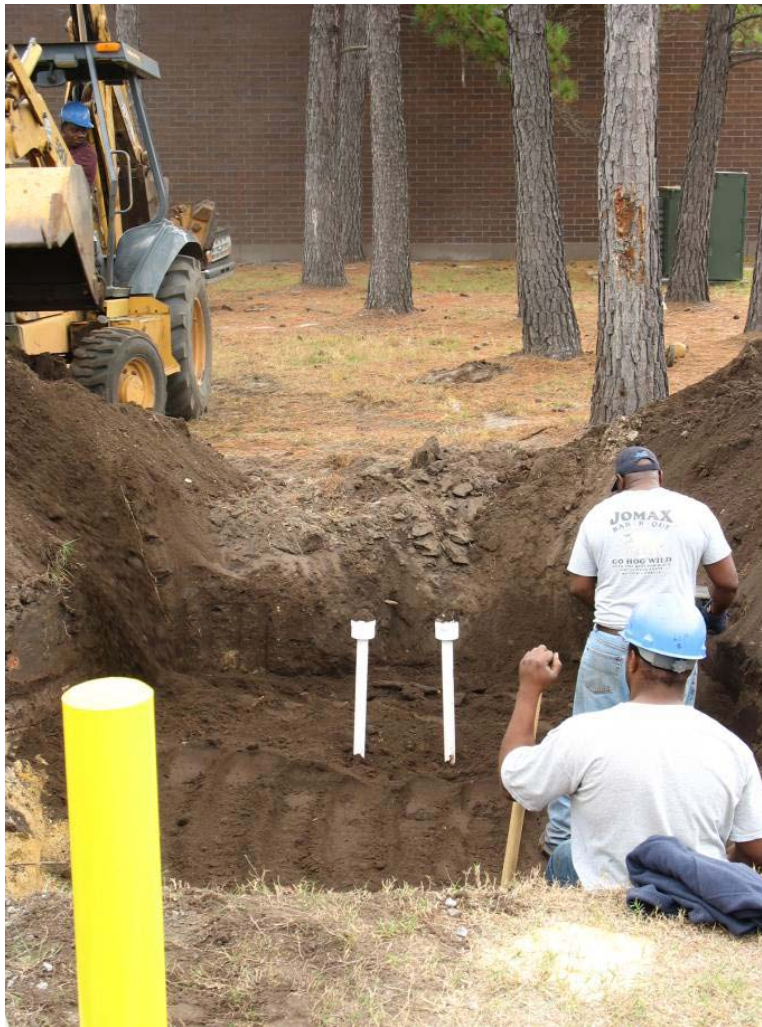
Figure 48. Backfilling site 4 excavation facing south to Building 646 from VP-16/17).

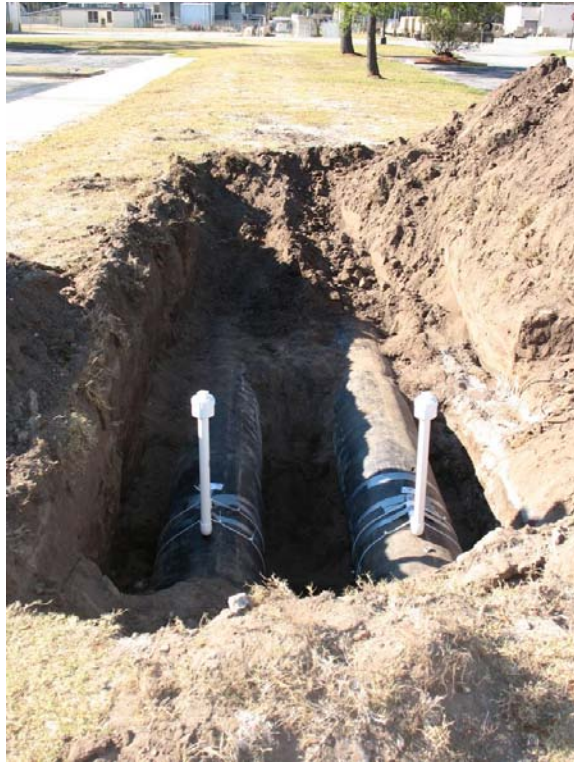
Figure 50. Heat flux sensor installation at site 3.

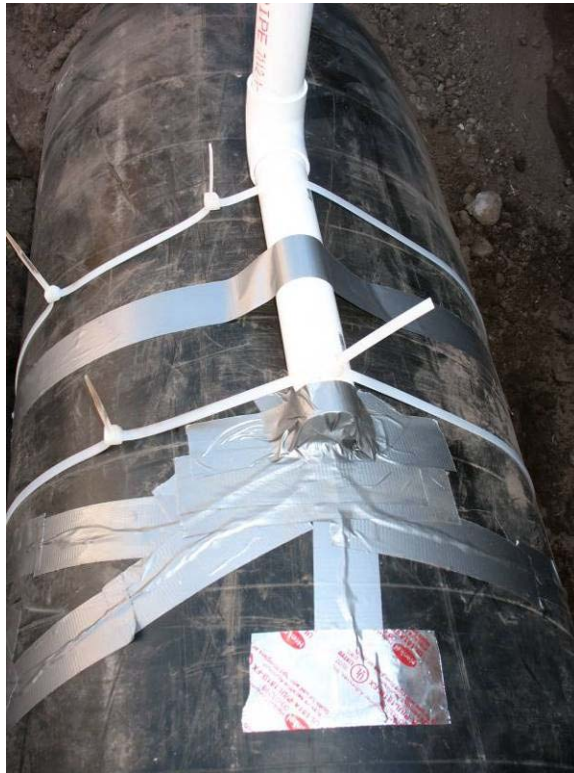
Figure 51. Heat flux sensor installation close-up.
